CAN WE LEARN FROM THE HERITAGE LOST IN A FIRE?

*Experiences and practises on the fire protection
of historic buildings
in Finland, Norway and Sweden*

National Board of Antiquities, Department of Monuments and Sites, publication no 26
(Museoviraston rakennushistorian osaston julkaisuja 26)

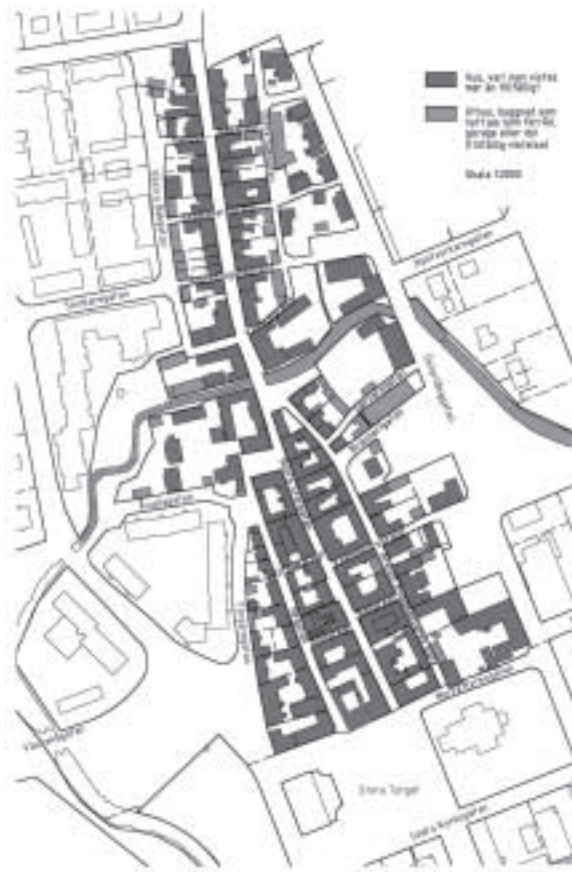
Plan of the old part of Eksjö.

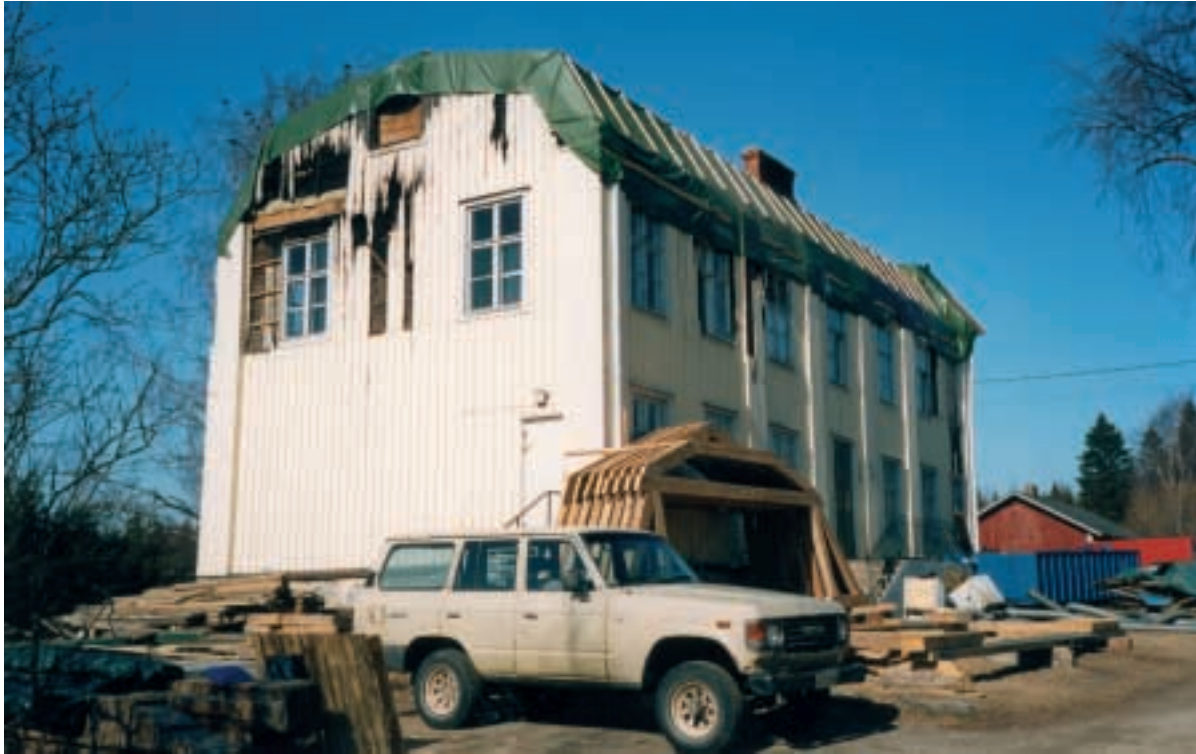
Åminneborg after the fire.

The fire broke out in the floor between the second living floor and the attic. The cause of the fire was a short circuit in an old electric wire, which resulted from condensation in the metal coating around the electric wires. It is interesting to note that the second living floor had been heated for only a few years.

The result of the fire was that all the roof structures and the attic were badly charred and the attic floor support beams were badly damaged. The ceiling, walls and the floor of the second living floor were badly damaged because of the amount of water used by fire fighters and there was also damage to the first floor.

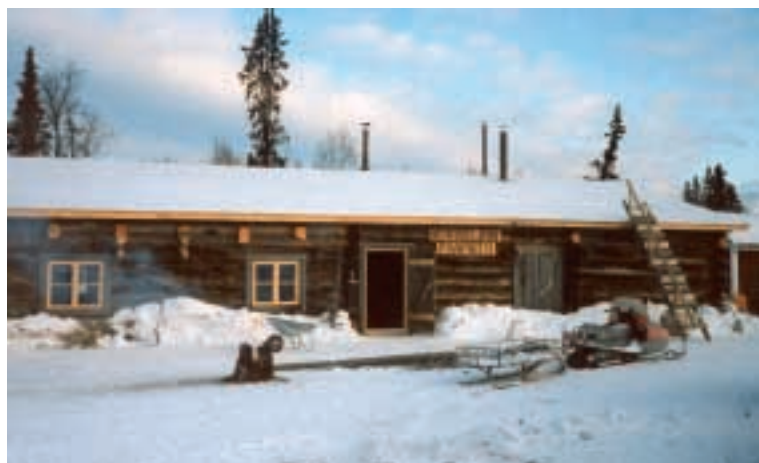
Kotaselkä before the fire, just after its restoration in 1990s.

After the fire, it was checked if there was any material (drawings, photos etc) on the building in the archives of the Museovirasto. Only one drawing (a plan), a few photos and some written documents of the renovations in 1990s were found and it was decided that rebuilding the hut was out of the question. A year later, the archives were searched again and some twenty good quality photos were found. There were pictures of the interior and facades. Also found were drawings to

a scale 1:50 showing the plan, facade and one section of the hut.

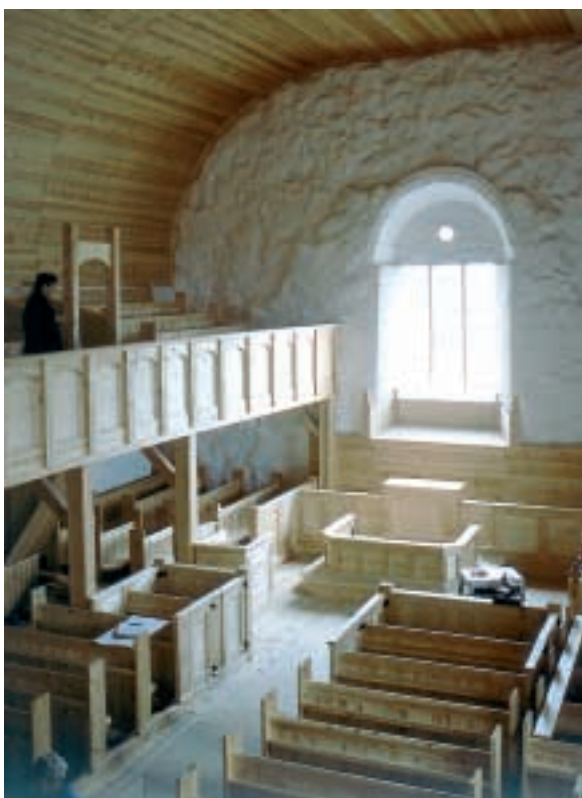
Interior of Tyrväå after rebuilding, without any paintings.

Despite difficulties, the roof was subsequently rebuilt as a training exercise and in accordance with the old model. The documentation was rather good but some details and dimensions were missing. The shingles were made by volunteers.

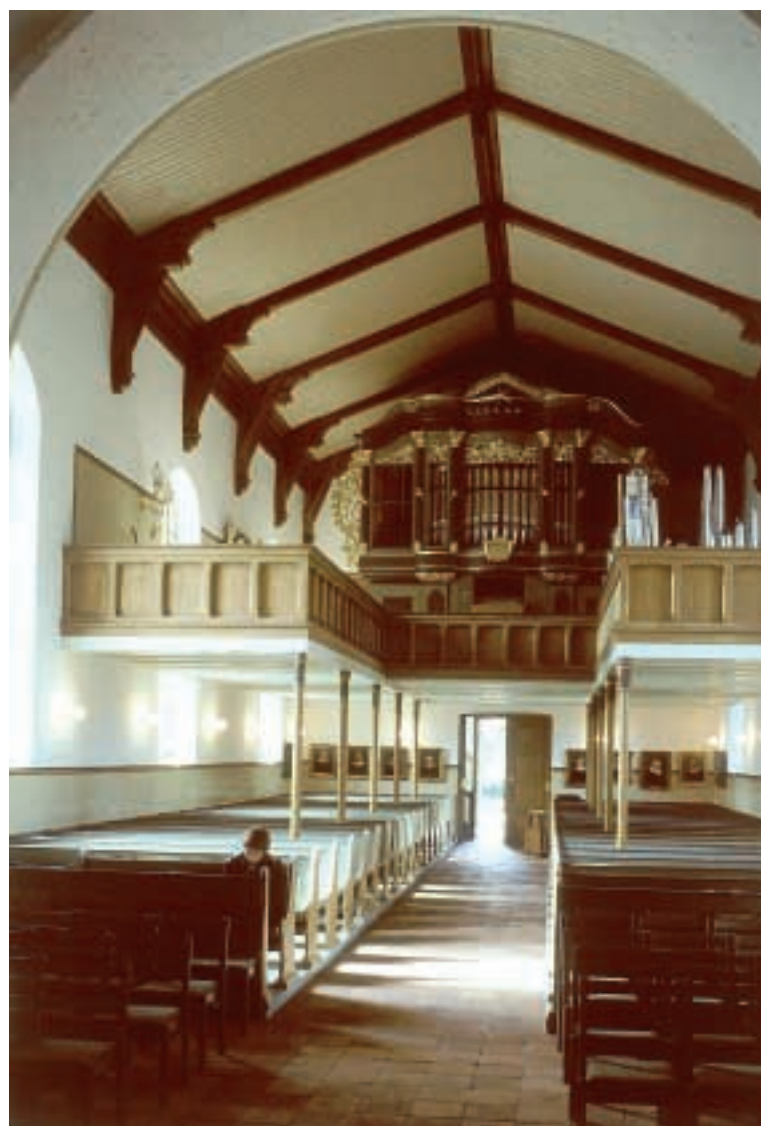
The interior of Eidsvoll Church reconstructed.

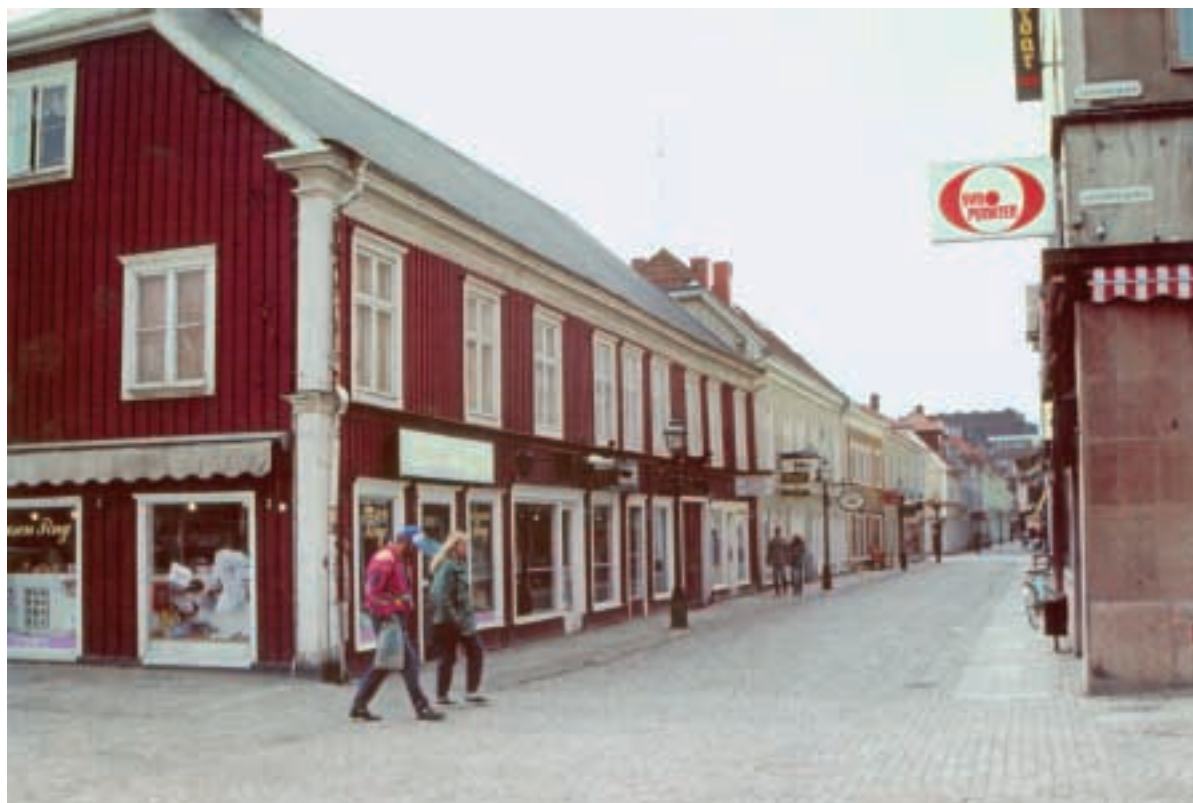
The block in Jönköping before the fire.

After the fire brigade had evacuated people they drew the lines from which they would fight the fire. They had good experience from fire drills in the very same buildings and they succeeded in keeping the fire within the limitation lines they had set. The firemen had a good water supply

from fire hydrants and the nearby lake. The action that gave “fog spikes” in the attics was the most effective, at least as long as the roofs were intact.

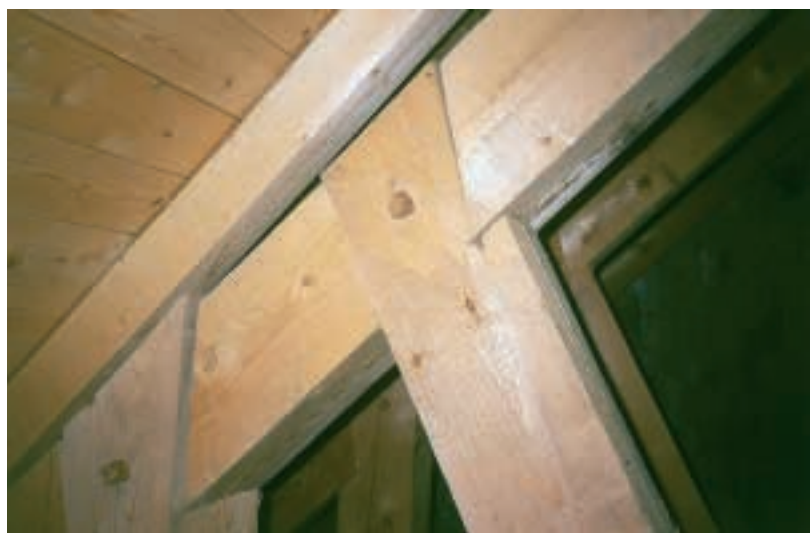
Detail of the new roof construction made of timber with wooden joints.

The roof construction was a very interesting aspect in rebuilding. The architect proposed a traditional wooden construction while the church board wanted to use concrete. The matter was studied carefully by evaluating the use of laminated timber and steel structures but finally it was noted that the old technique with wood would be the quickest, easiest and cheapest way to rebuild the roof. So skilful carpenters were employed and all parts were made on the site in order to adjust them to the existing wall structures.

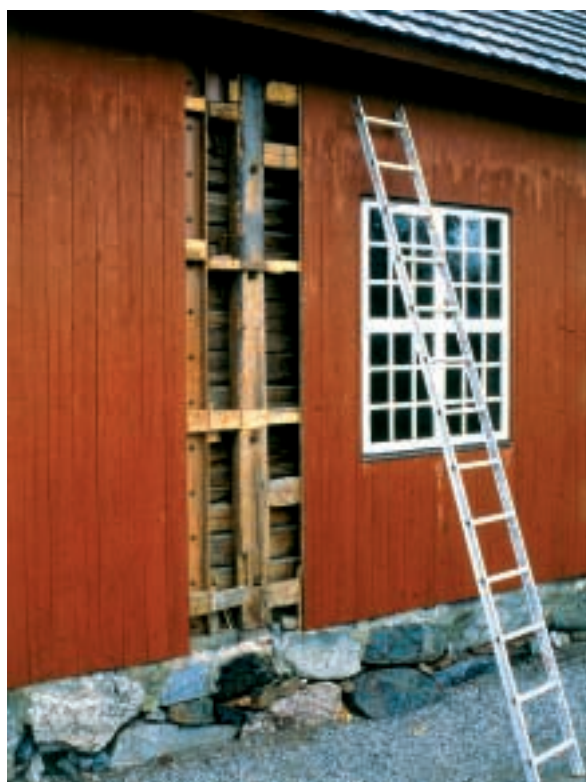
The gap between the log wall and the exterior boarding.

The existing wooden exterior boarding on the timber walls is from 1960s. The logs in the walls were soft and they were no longer able to bear the load well; a new supporting frame was needed all over the church. This was made of 4" x 4" wooden beams. This causes a serious risk of fire because there is a gap between the log wall and the boarding. The roof is also of double construction. A shingle roof visible but underneath there is an older roof made of smaller and thinner shingles. There is also 10-cm wide gap that forms a flue in case of a fire.

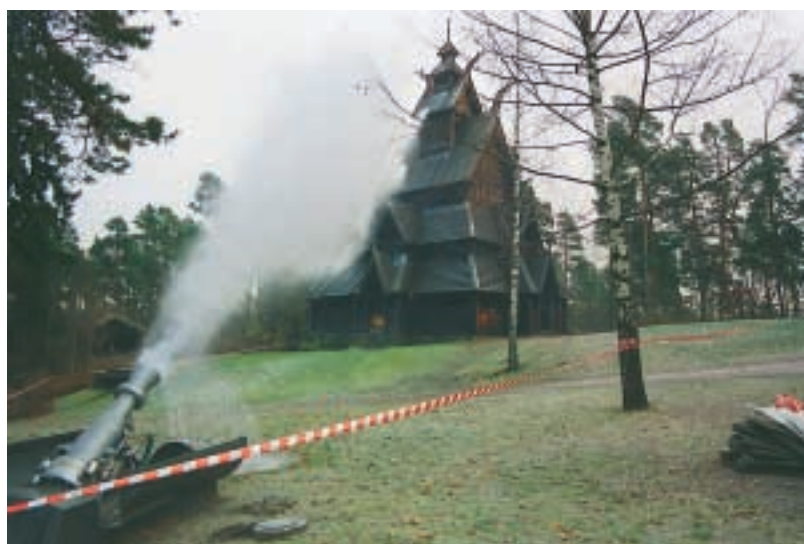
The water mist cannon in the vicinity of Gol stave church.

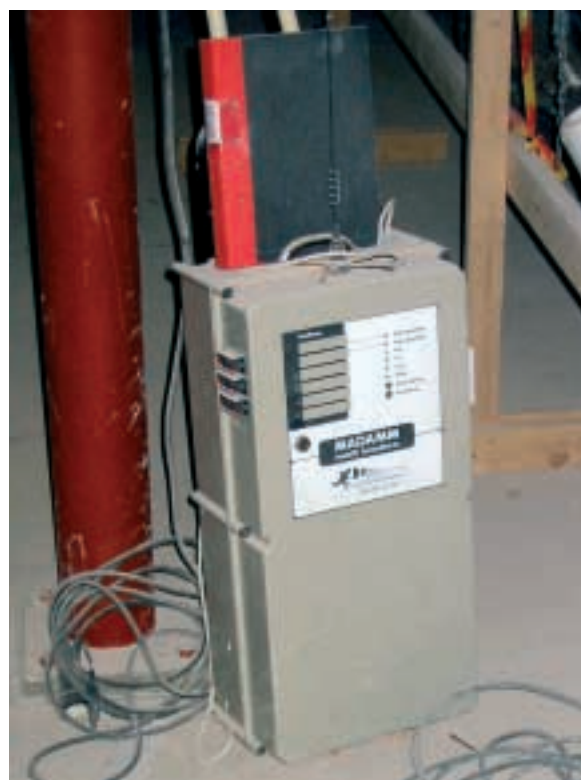
“MADAMM” a movable air sampling fire detector.

- Work on repairs should be carried out so that a building is divided into fire compartments.
- A portable fire alarm system called MADAMM can be used; its working range is 50m and it is a sampling system (should be used only when there is no work on in the site, such as at night and on weekends, because the dust can cause problems). The price for one unit like this is about 45 000 SEK (2003).
- All workers on the site are trained from the very beginning to consider fire safety.
- The rescue of human beings must be ensured in the event of a fire; fireproof elevators can be used (there is high pressure in the elevator well; it is normal technology for high-rise buildings). These fireproof elevators are in use not only during the building activity but they also function normally even in the event of a fire.

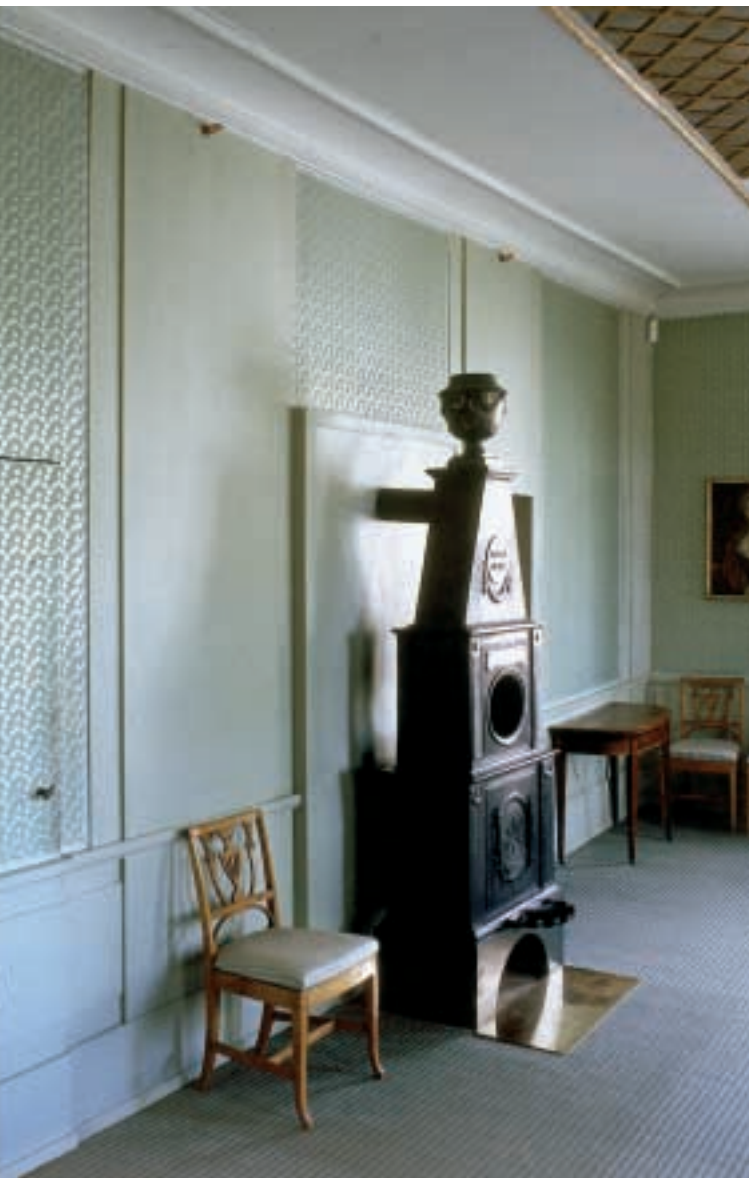
Sprinkler heads do not disturb the space very much if installed carefully.

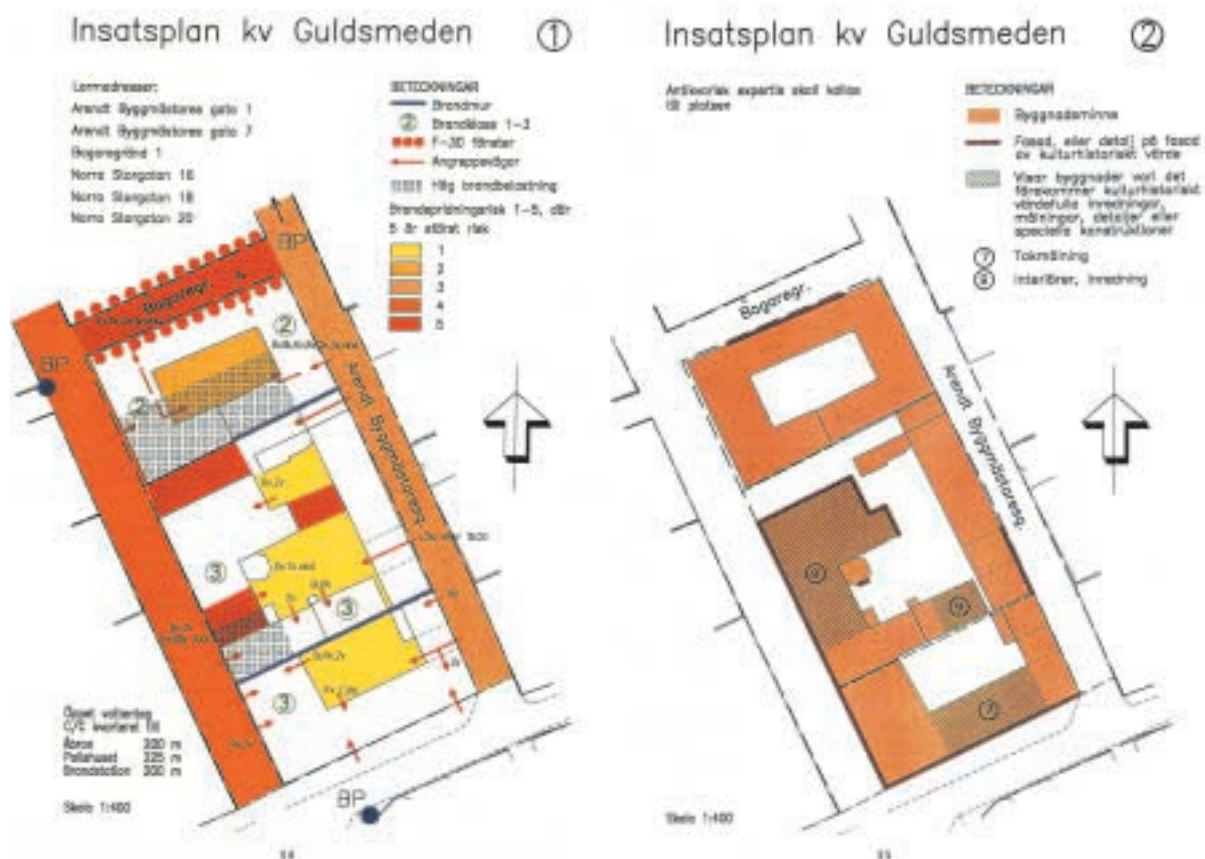
An example of rescue plan drawings in Eksjö.

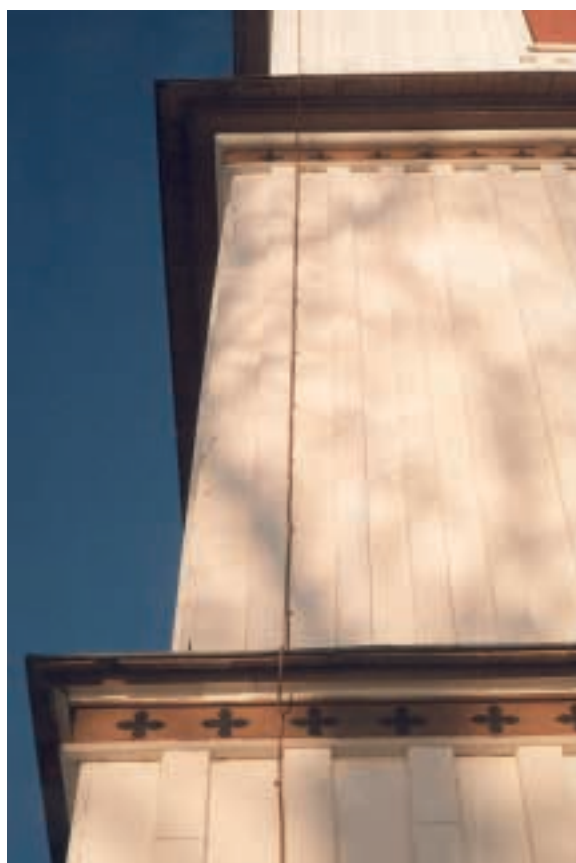
A lightning conductor installation in Norway.

Lightning is a major cause of church-fires. What seems to be a fire caused by an electric fault can in reality be caused by lightning. It is therefore important that all electric installations are given the necessary lightning protection. Buildings in positions where lightning strokes are likely, churches for instance should also have an external lightning protection system. The Riksantikvaren has

developed methods for fixing external lightning conductors in harmony with old buildings. In Norway, lightning conductors can be installed straight to a surface and they do not have to be fixed with very visible fasteners.

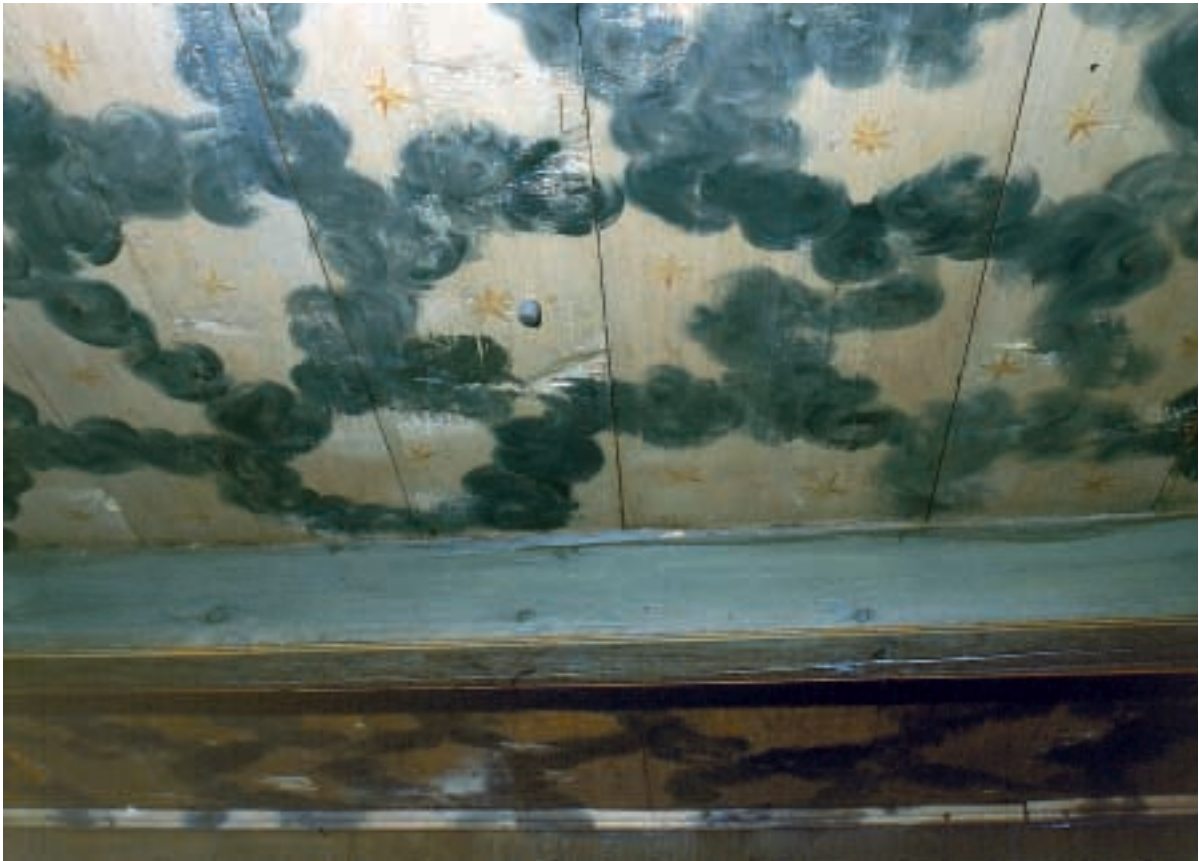
The only visible part in air sampling systems is the tiny end of a plastic pipe – if it is possible to hide the main pipes in such places as the attic above.

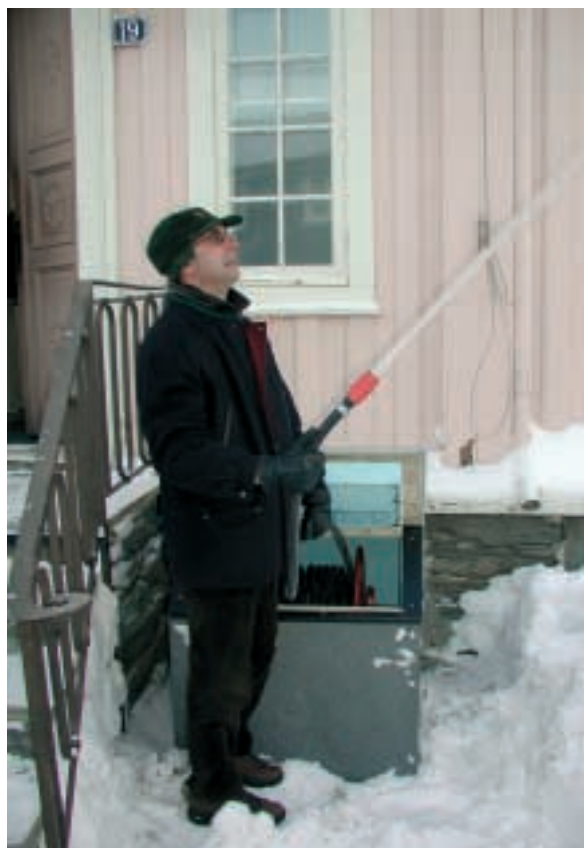
Plastic fire hoses are easier to use than the ones made of cloth because it is not necessary to pull it out full length.

continuous supply of water. A fire extinguisher has a limited working time. Moreover, hoses are often easier to use. Fire hoses should therefore be installed for full internal coverage of the building. These are mainly for use during the first minutes of a fire.

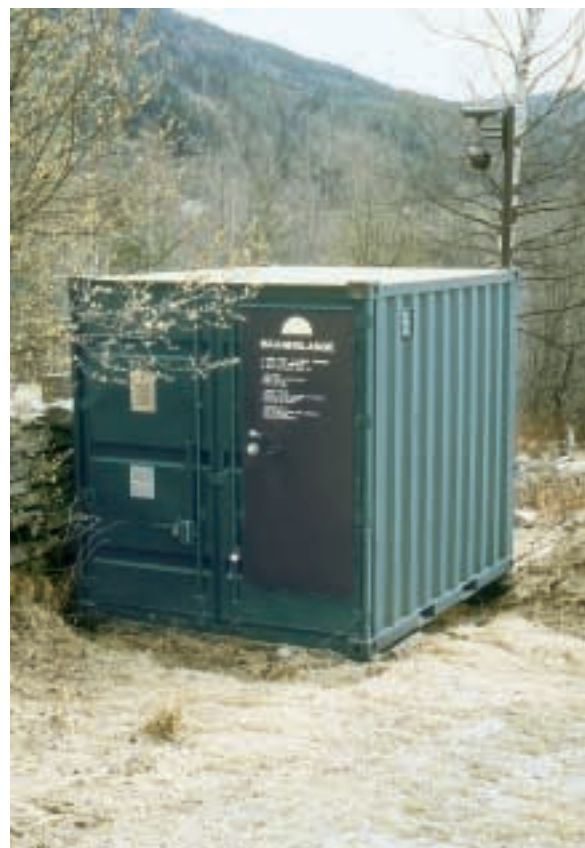
A mini fire station in Norway.

These are standard containers with a water reservoir of 6 or 10 cubic meters and a fifty-meter fire hose. They were used at stave churches in Norway until a sufficient water supply was provided. They have now been moved to museums and churches as a temporary measure.

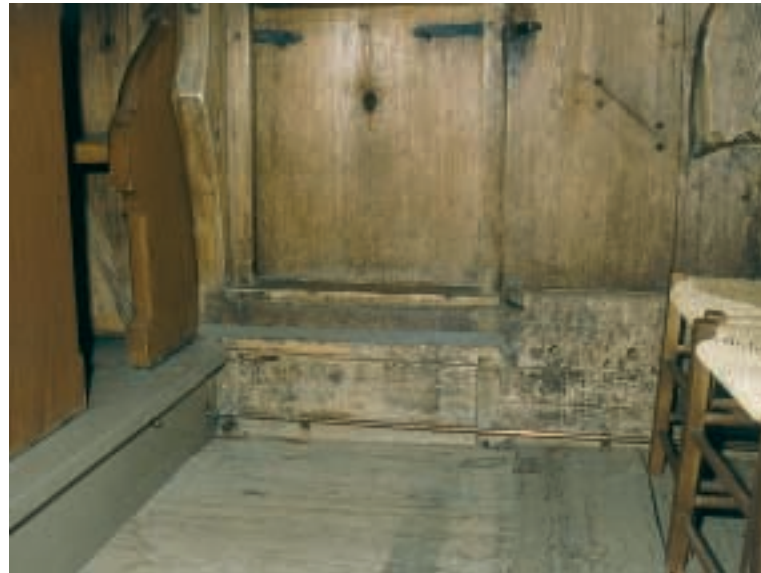
Copper sprinkler pipes match well with aged wood.

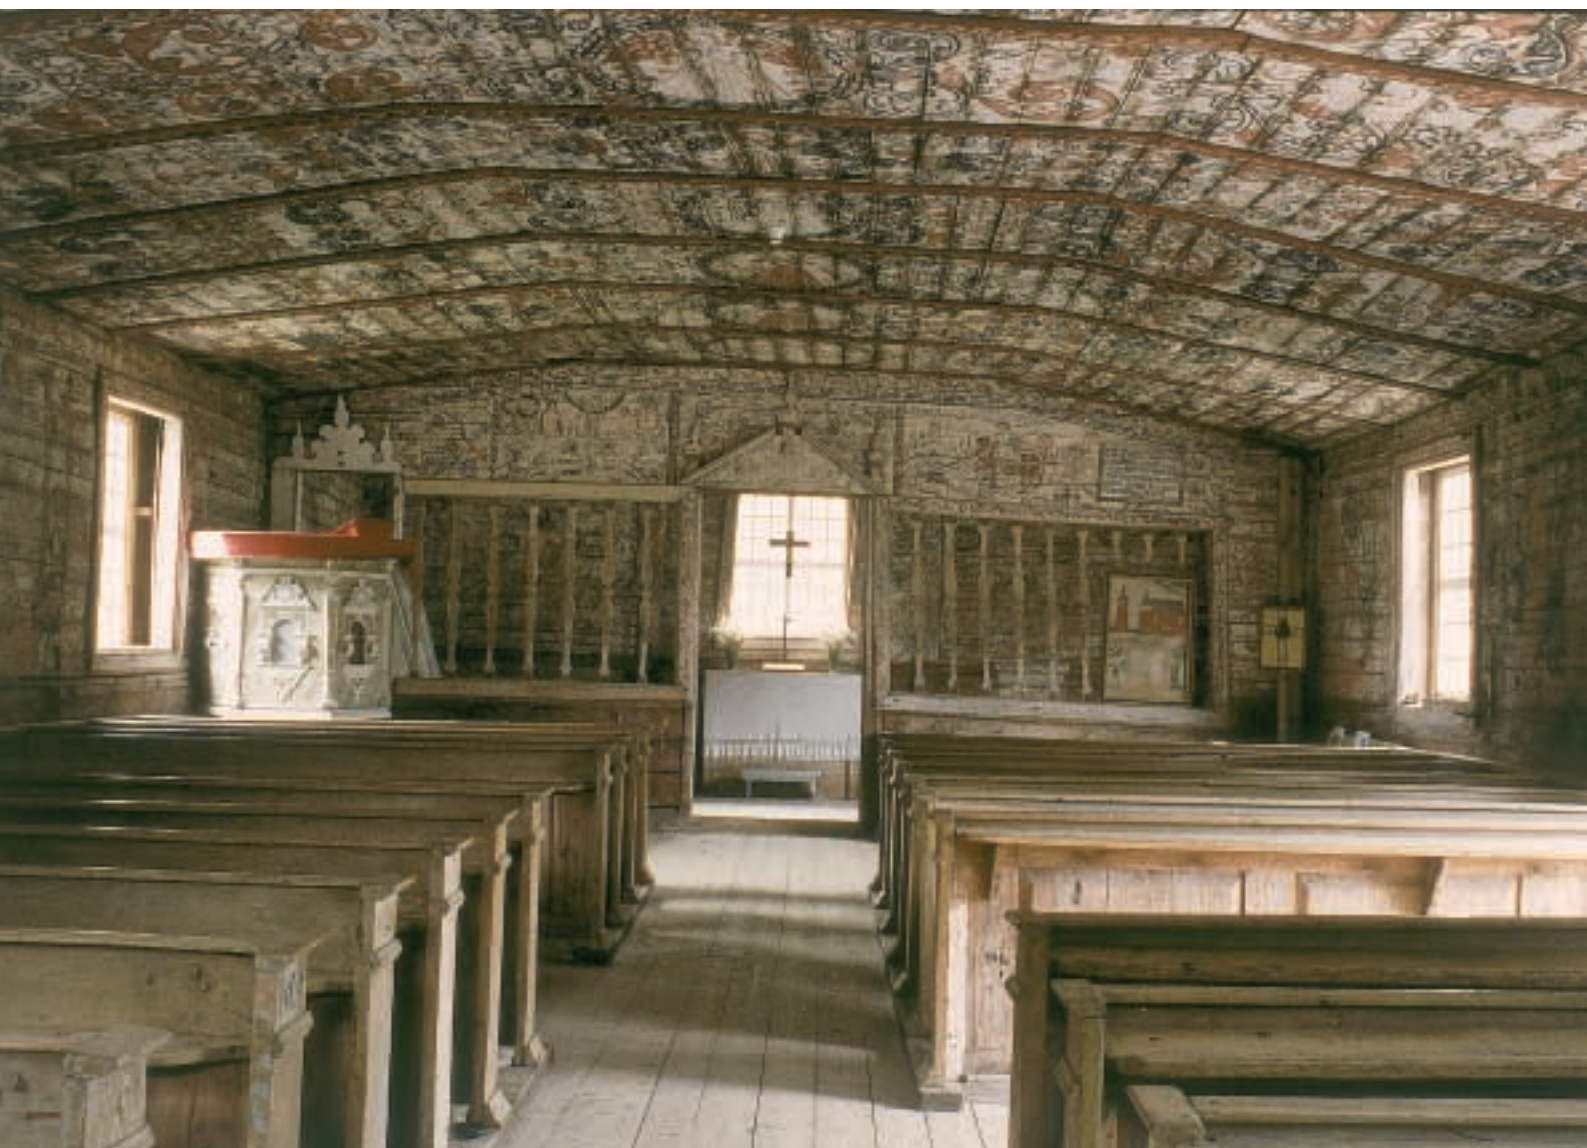
Many indoor paints such as sensitive glue-based paint do not stand the amount of water that traditional sprinkler systems need, so a water mist system is more suitable for this kind of interior. (Pyhämaa Church)

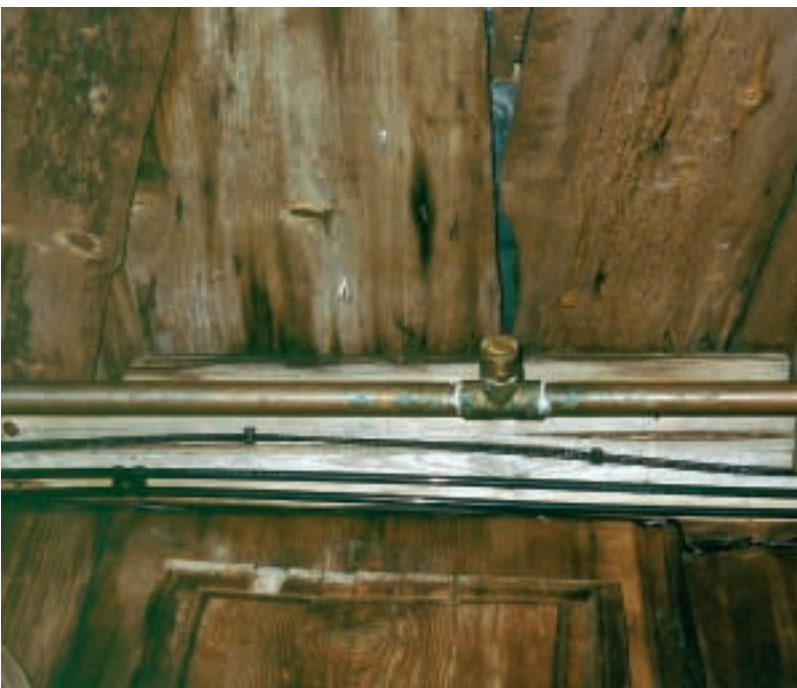
A fire detector for the release of automatic fire suppression systems, for instance a water-mist that consists of two thin plastic tubes. It is discrete and functions without electricity, but there have been some problems with it, such as incidents where the tubes have been cut by animals.

Many water mist installations are equipped with double plastic tubes to reduce the risk of false releases. In some churches, there are two separate systems to release the water mist, for instance plastic tubes + air sampling.

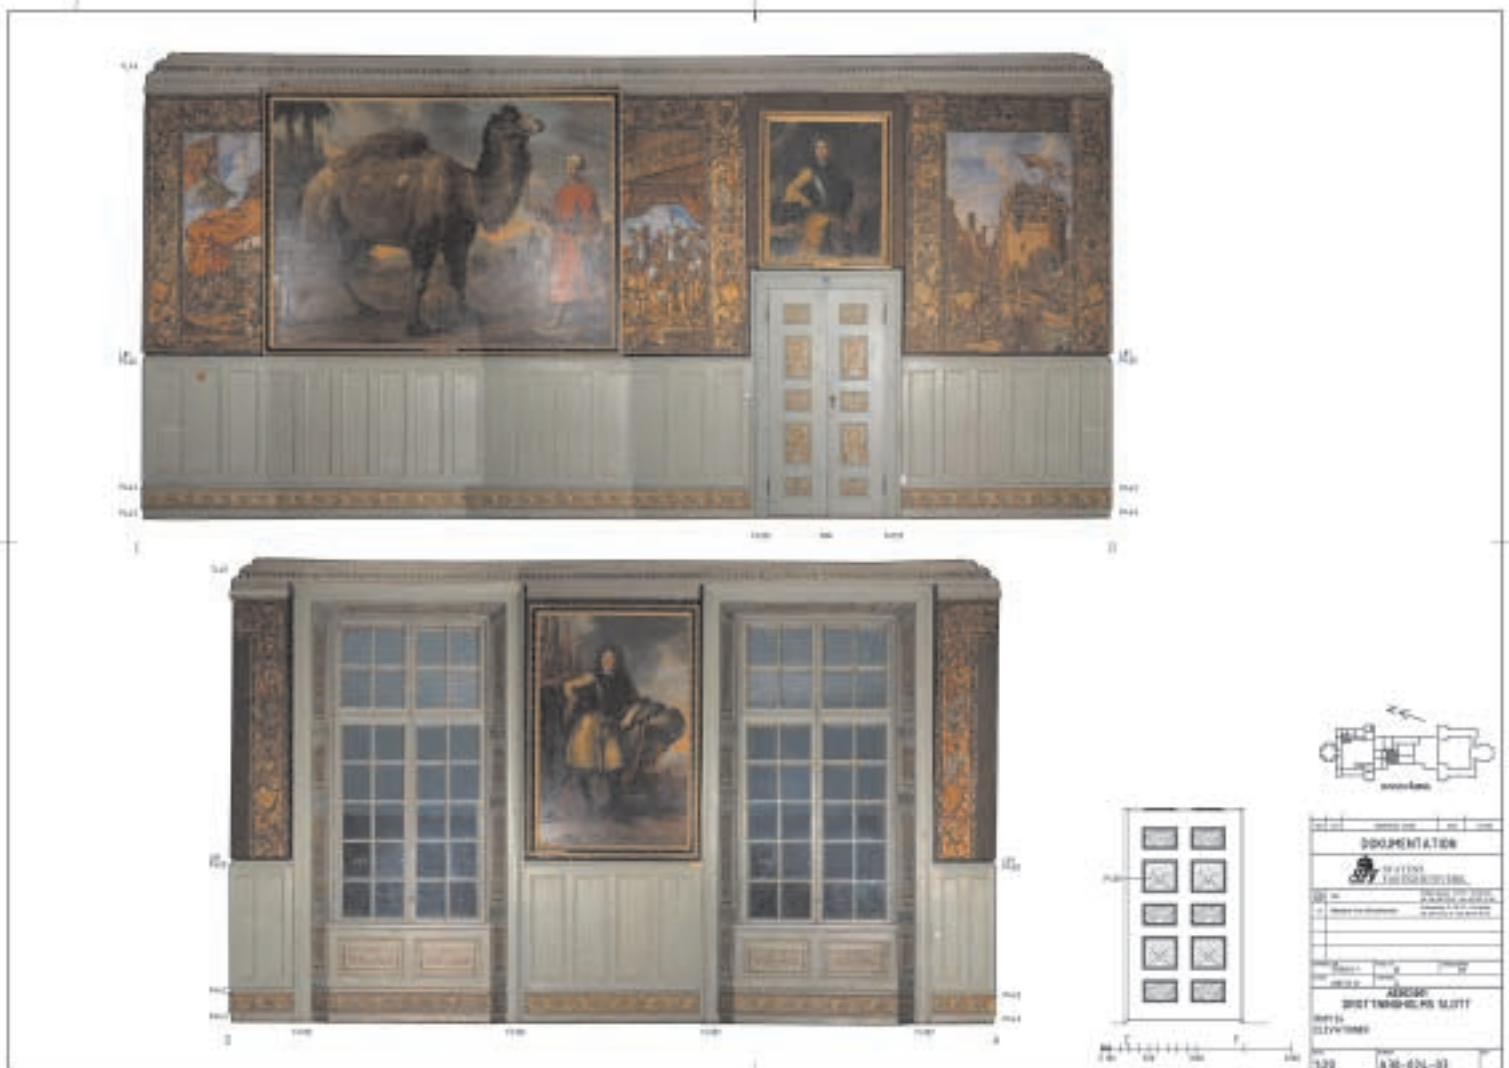
A photographic documentation drawing showing two interior walls in Drottningholm. (By Architect office AIX)

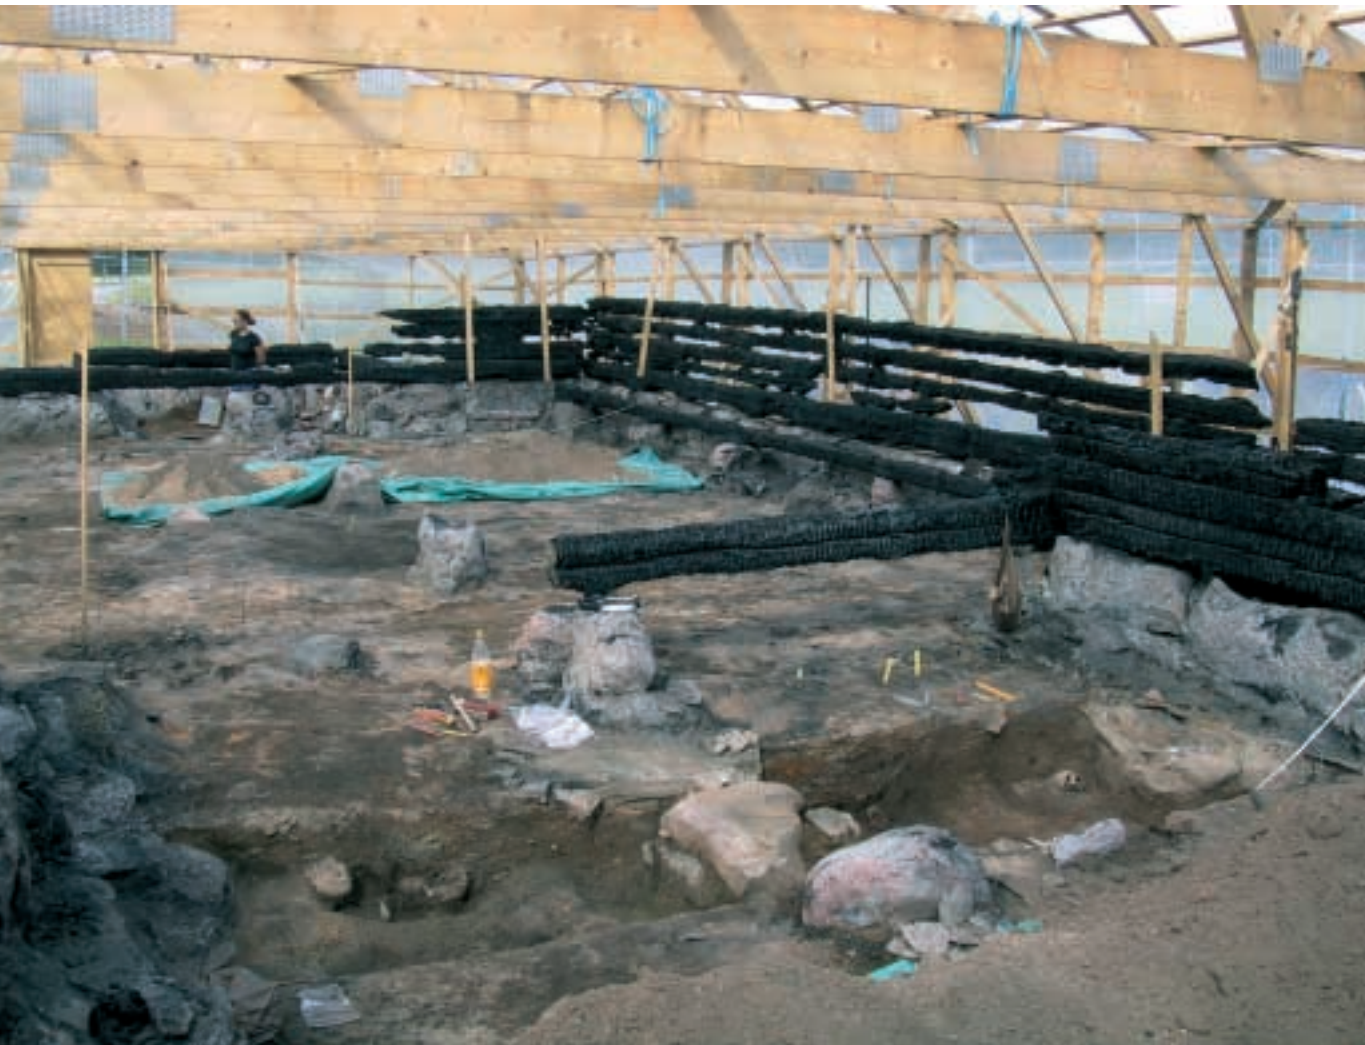
Protective construction was built to cover the remains of Södra Råda.

Thereafter, a fence and a powerful lighting were put up around the building. Some weeks later a construction was built over the former church to cover and protect the fire remains so they could later be investigated.

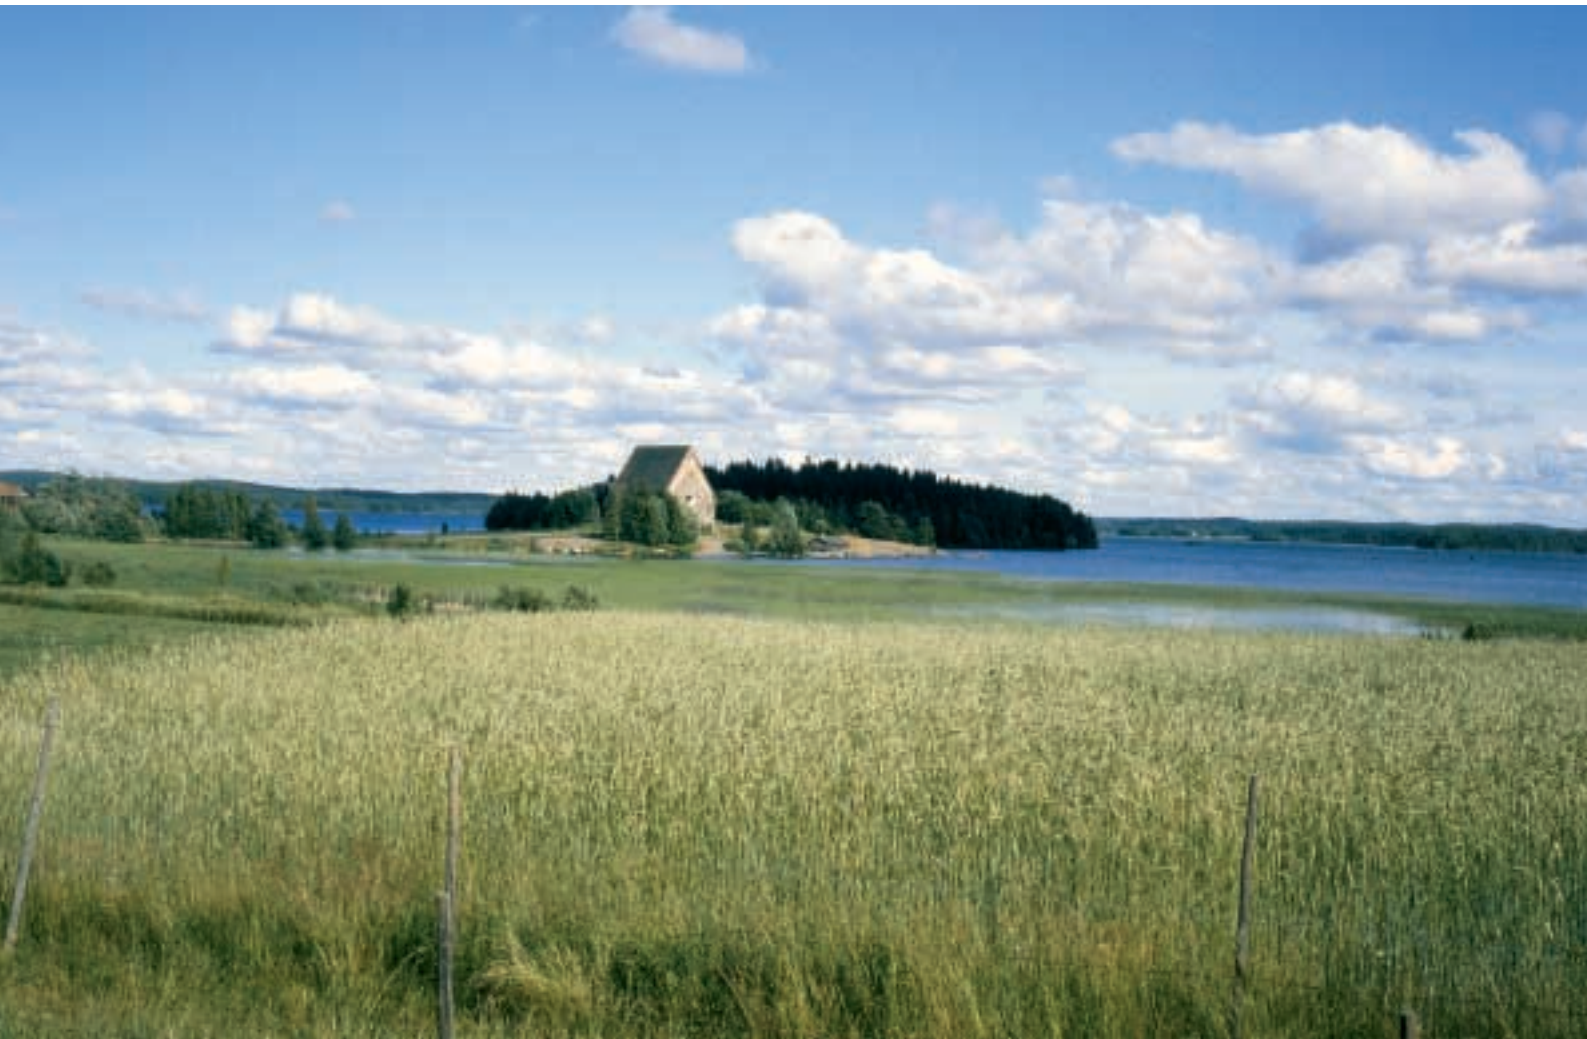
All cracks in the stonewalls were marked on the existing drawings of Tyrväå church.

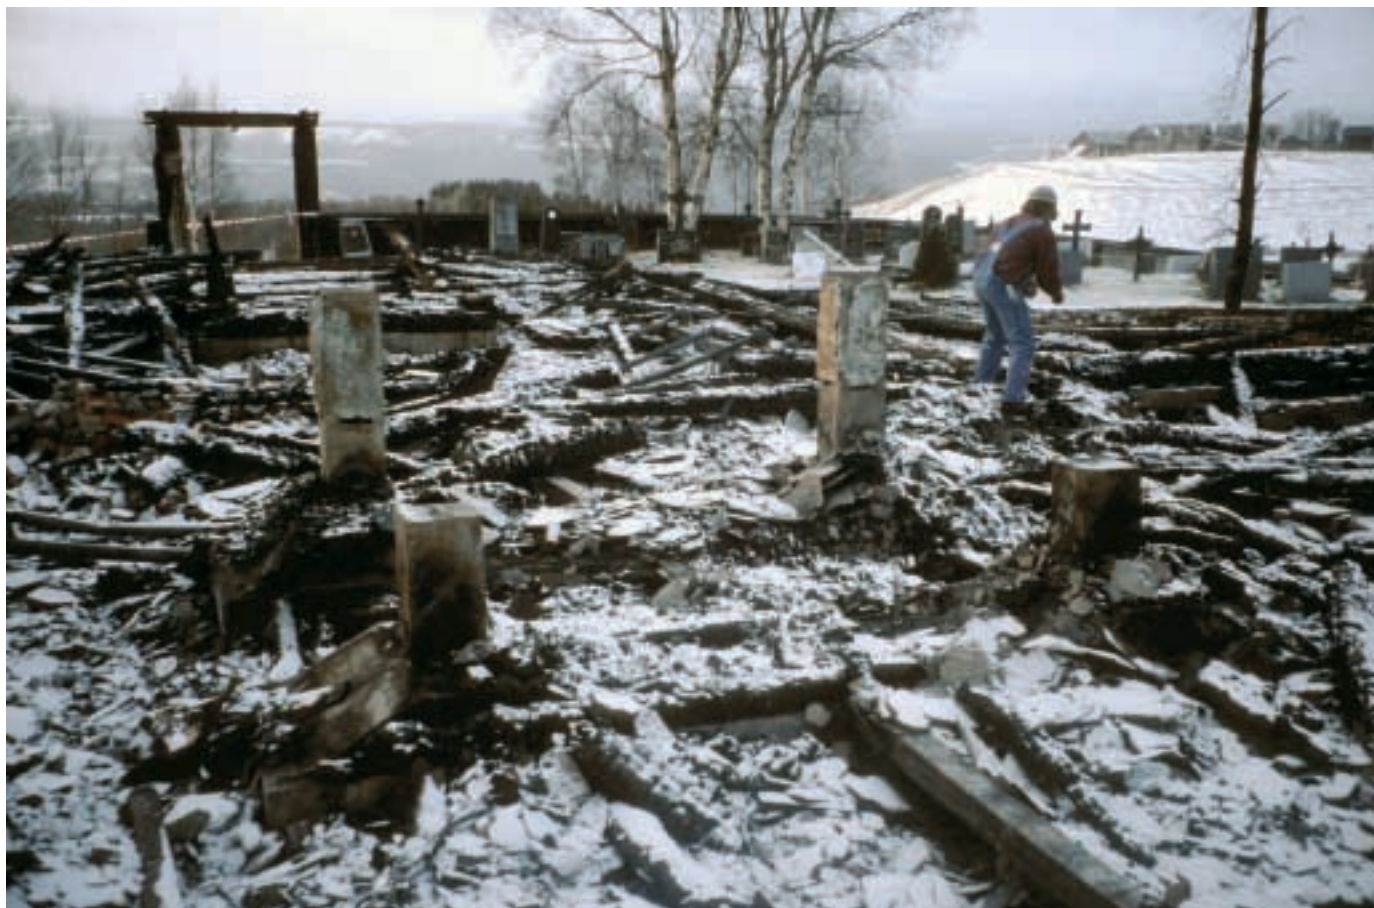
The starting point for investigations after a fire can be like this (Innset church, Norway).

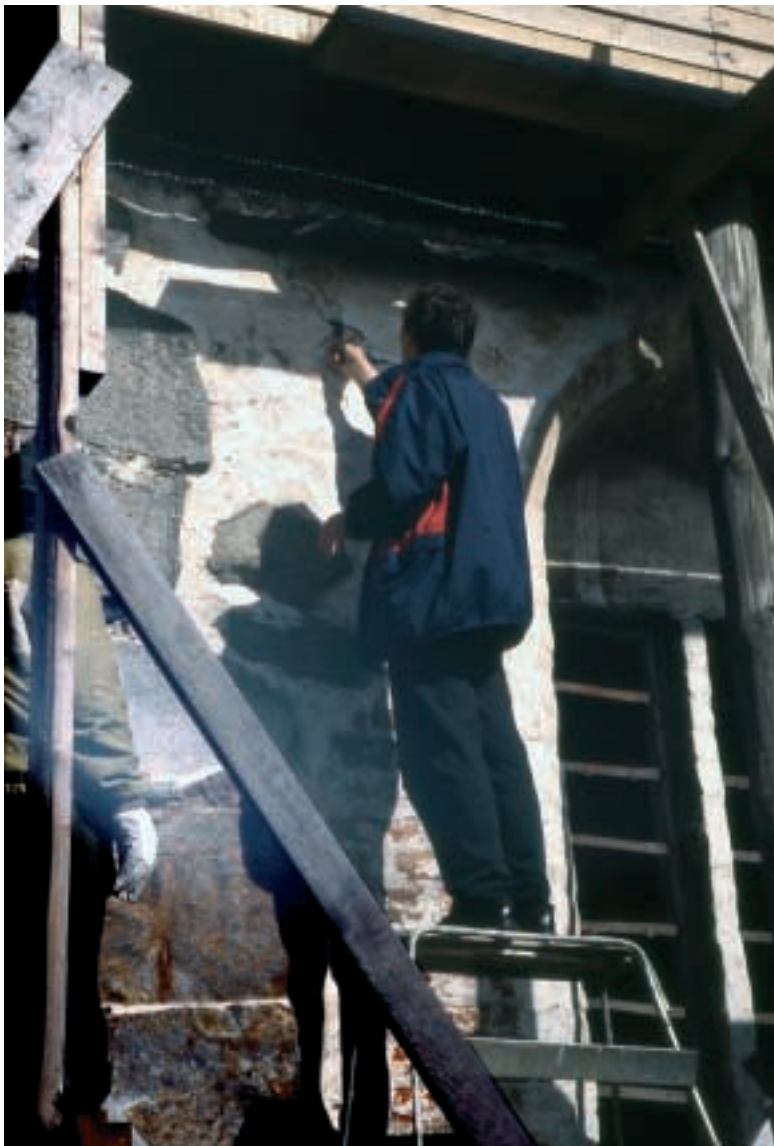
The remains in Tyrväå were investigated carefully.

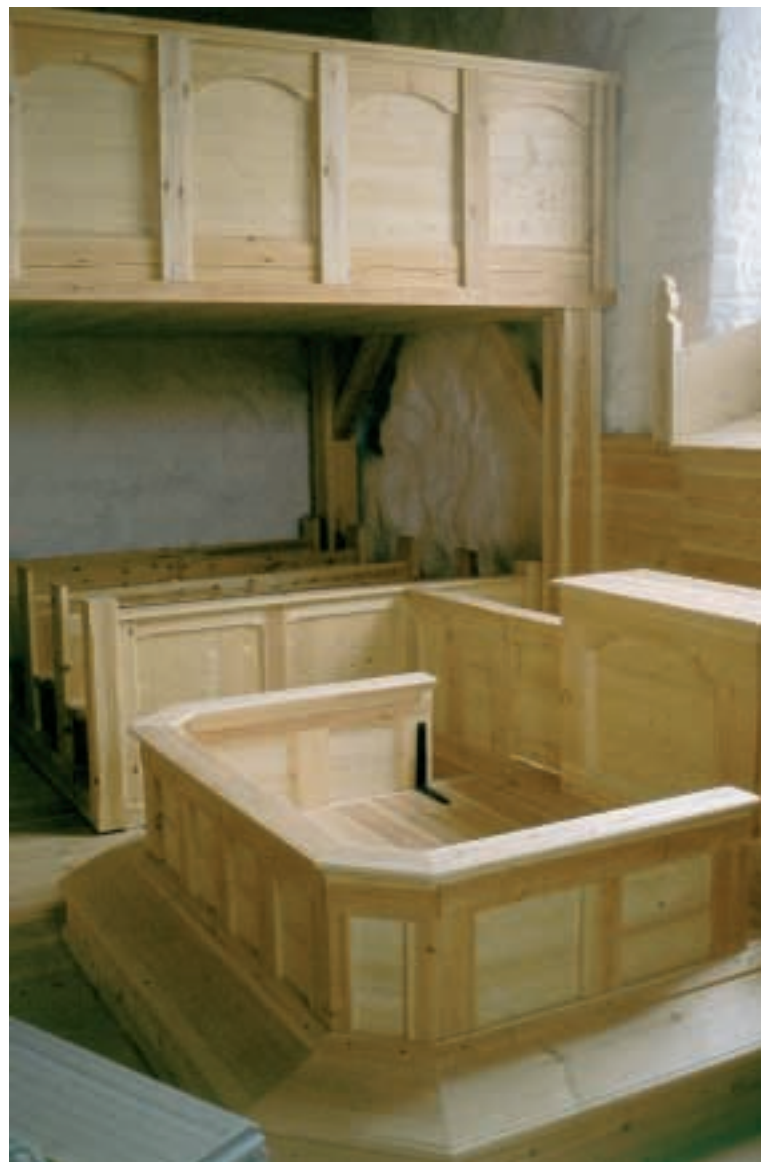
The boarding in the panels for paintings was made horizontal while in the old Tyrvää Church it was vertical.

In this case, the idea was to restore the lost atmosphere and not the lost interior. In fact, the rebuilding of the interior of Tyrvää Church followed the Venice Charter by showing in some details of the wooden structures that it is not the original. It was not meant to be a copy of the burned interior, even if it does look very much like it in reality.
