CAN WE LEARN FROM THE HERITAGE LOST IN A FIRE?

*Experiences and practises on the fire protection
of historic buildings
in Finland, Norway and Sweden*

National Board of Antiquities, Department of Monuments and Sites, publication no 26
(Museoviraston rakennushistorian osaston julkaisuja 26)

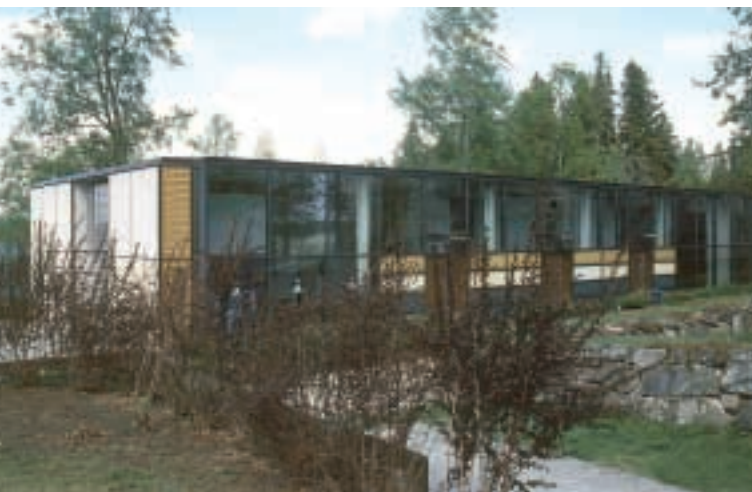
Karjalohja "new" Church from 1977.

The church in Karjalohja was left as a ruin because the Museovirasto demanded so. Only the brick walls remained in 1970. They were strengthened with concrete to withstand the cold and humid Nordic climate. A box of glass and steel was built next to the church in 1977. In its leaflet, the congregation says that the new glass church has caused anxiety in people because of its modern and severe architecture. There is a story about a small boy who said to his mother "what a congregation, they even have a swimming hall here".

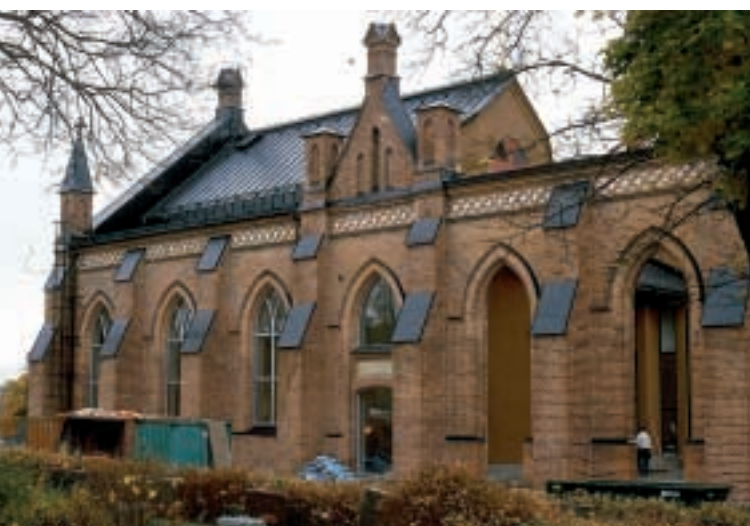
The new church in Trönö was built inside the remains of the old church.

Trönö Church, built of bricks in 1893–1895, burnt in 1998. It stands out from other churches in that a new church was built inside the ruin of the old one. A smaller church was built in the chancel and front part of the aisle. The new church is of a modern design. The remaining part of the aisle is now used as an open yard. The spire of the tower walls has been replaced by a construction made of glass.
